# Handle old laryngoscopes with care

Department of Anaesthesiology and Critical Care, JIPMER, Puducherry, India

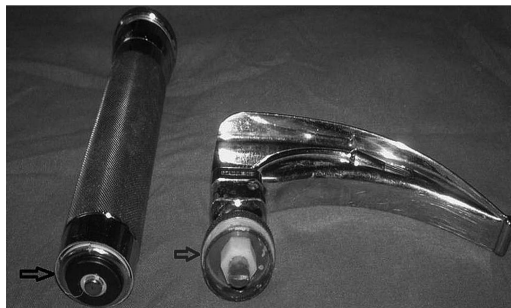
A 30-year-old woman with fibroid uterus was operated on for myomectomy under general anaesthesia. Preoperative evaluation revealed adequate mouth opening, neck extension, thyromental distance and Mallampati grade 1. In the operating room, anaesthesia was induced with fentanyl and propofol under standard monitoring. Muscle relaxation was achieved with vecuronium. Laryngoscopy was attempted with a size 3 McIntosh laryngoscope blade after mask ventilating the patient for 3 min. Laryngoscopy revealed a Cormack Lehane grade 3 view. External laryngeal manipulation with increased axial force along the laryngoscope handle was attempted. During this time, the laryngoscope blade along with the hinge piece separated from rest of the handle at the weld line. Fortunately, none of the batteries or other parts slipped into the patient's oropharynx. The patient was mask ventilated and laryngoscopy was attempted with another laryngoscope. Subsequent tracheal intubation was successful with help of a stylet. On closer examination of the damaged laryngoscope handle, breakage was found along the line where the knurled barrel of the handle was welded into the proximal cast fitting of the hinge piece (figures 1 and 2).

**Figure 1** Hinge piece separated from knurled barrel of handle.

- ▶ Besides checking for the functional status of laryngoscopes (light intensity, fitting bulb), integrity of blade and handle assembly should also be tested by applying force in extended working position.

- ▶ Institutes should implement a system of tracking the years of usage of individual laryngoscopes and regularly inspect and replace faulty equipment.

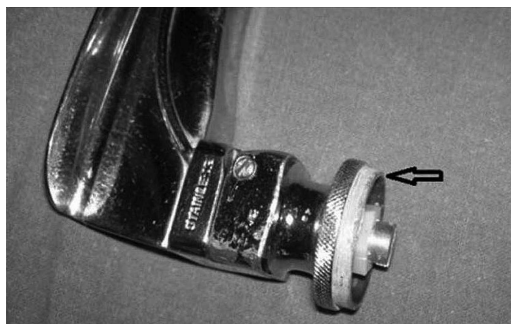
Failure of welding can be attributed to laryngoscope handle wear; the laryngoscope had clearly been

in use for many years. The weld line between the hinge piece and knurled barrel of the handle acts as a fulcrum and is subjected to a force of 10–30 newton during laryngoscopy. This force can reach 100 newton during a difficult laryngoscopy and in our case could have caused the failure of the welding.<sup>1</sup> Breakage at hinge and ingestion and loss of rivet in a MacCoy blade have been reported earlier.<sup>2</sup>

**Figure 2** Failed welding at hinge piece.

- ▶ Manufacturer-specified instructions should be strictly adhered to while cleaning and sterilising laryngoscopes. Healthcare Infection Control Practices Advisory Committee (HICPAC) guidelines for disinfection and sterilisation in healthcare facilities as proposed by Centres for Disease Control and Prevention categorise laryngoscope blades as semicritical items that need to be subjected to high level disinfection for exposure time of 12–20 min at  $\geq 20^{\circ}\text{C}$ .<sup>3</sup> Among the recommended disinfectants, hydrogen peroxide 7.5%, hydrogen peroxide 1% with peracetic acid 0.08% and hypochlorite are known to corrode metal instruments. However, no specific category has been assigned to laryngoscope handles. Hence, unless contaminated by oropharyngeal secretions, laryngoscope handles could be considered as non-critical items and subjected to intermediate to low level sterilisation with exposure time of  $\geq 1$  min using ethyl or isopropyl alcohol (70–90%), sodium hypochlorite (5.25–6.15%), phenolic germicidal detergent solution, iodophor germicidal detergent solution or quaternary ammonium germicidal detergent solution—none of which produce significant corrosion of metals—to minimise wear and tear.
