Severe metallosis following oxidised zirconium wear in total hip arthroplasty

DESCRIPTION

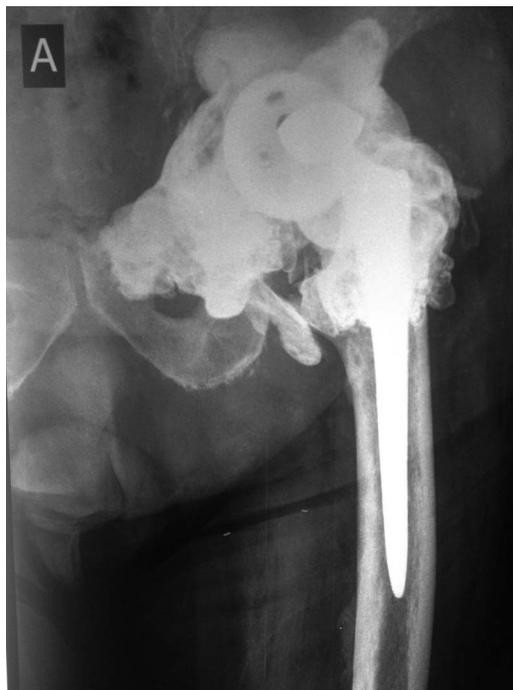
Figure 1 Anteroposterior plain radiograph, without use of contrast medium, showing an extensive cloud sign of the periprosthetic tissues, failure of the acetabular cup and wear of the oxinium femoral head.

We present a case of a man aged 81 years who underwent a primary cementless total hip arthroplasty. Eight years after the index surgery, failure of the arthroplasty was revealed by the presence of the radiographic 'cloud sign' (figure 1). The original components used were the R3 acetabular cup with a Synergy femoral stem, highly crossed linked polyethylene liner and an oxidised zirconium (Oxinium) femoral head (Smith & Nephew Synergy, Memphis, Tennessee, USA). The initial investigation included a CT scan, full blood tests and a tissue biopsy which revealed no malignancy. Subsequently, during revision surgery, there was extensive osteolysis with metallosis. There was black staining of the periprosthetic soft tissues and the hip pseudocapsule was filled with thick black fluid (figure 2). There was severe wear of the femoral head and the polyethylene liner. Following debridement and removal of the components, a revision cementless stem and acetabular cup was used to reconstruct the hip joint.

The cloud sign in the plain radiographs—also known as the bubble sign—is an indication of soft tissue metallosis.¹ The findings are usually subtle

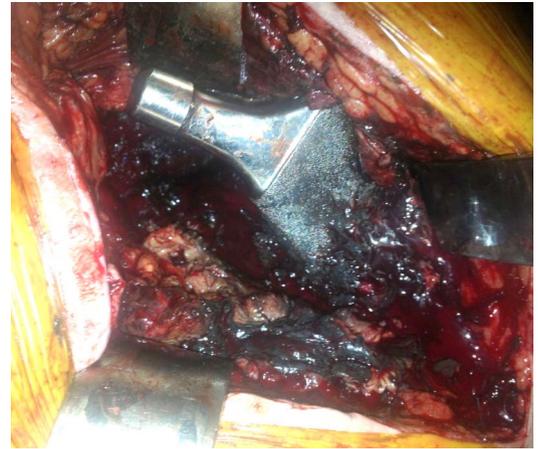
Figure 2 Intraoperative photograph during revision surgery. There is black staining of the periprosthetic tissues and osteolysis around the peritrochanteric area.

and the debris is well tolerated by the patients. A few cases with characteristic radiographic findings are reported in the literature, but to the best of our knowledge, the present case is the most impressive due to the extent of the metallosis.^{2 3} Oxidised zirconium is a metallic alloy with a ceramic surface that combines the best of metal and ceramics. However, if the outer surface of the head is damaged, then rapid destruction of the head can occur.
