A mass obstructing mechanical prosthetic heart valve: thrombus or pannus?

DESCRIPTION

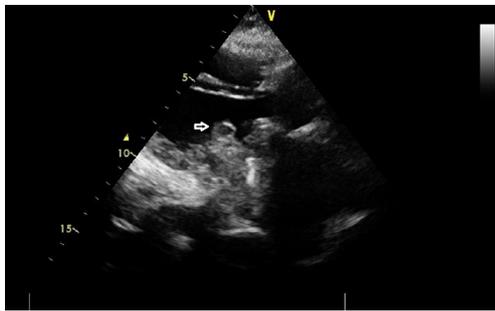
Figure 3 Transthoracic echocardiogram parasternal long-axis view, showing the thrombus (arrowhead) attached on ventricular side of mechanical prosthetic mitral valve. Note the acoustic shadow of the metallic prosthesis, obscuring the visualisation of leaflets and extent of attachment of the thrombus.

for 3 days. She had undergone a mitral valve replacement with a mechanical bi-leaflet prosthesis 6 months prior for severe rheumatic mitral regurgitation, following which she was asymptomatic. Examination revealed blood pressure of 90/64 mm Hg and sinus tachycardia with heart rate of 120/min along with decreased intensity of the closing click on auscultation. She had a suboptimal international normalised ratio (INR) of 1.36. Fluoroscopy showed severely restricted leaflet opening (**video 1**). Transthoracic echocardiogram revealed significantly increased gradient across the mitral valve prosthesis (**figure 1**). It also revealed a small rounded 8×10 mm, minimally mobile, echogenic mass with central echolucent area, attached to the prosthetic ring on the ventricular side (**figures 2**

and 3). Extent of its dimensions and leaflet attachment could not be assessed, especially because of the unavailability of TEE at that time.
